AN EVALUATION OF THE HAGERSTOWN, MARYLAND WATER POLLUTION CONTROL PLANT

National Field Investigations Center
Cincinnati, Ohio

November 1973

NOVEMBER 1973

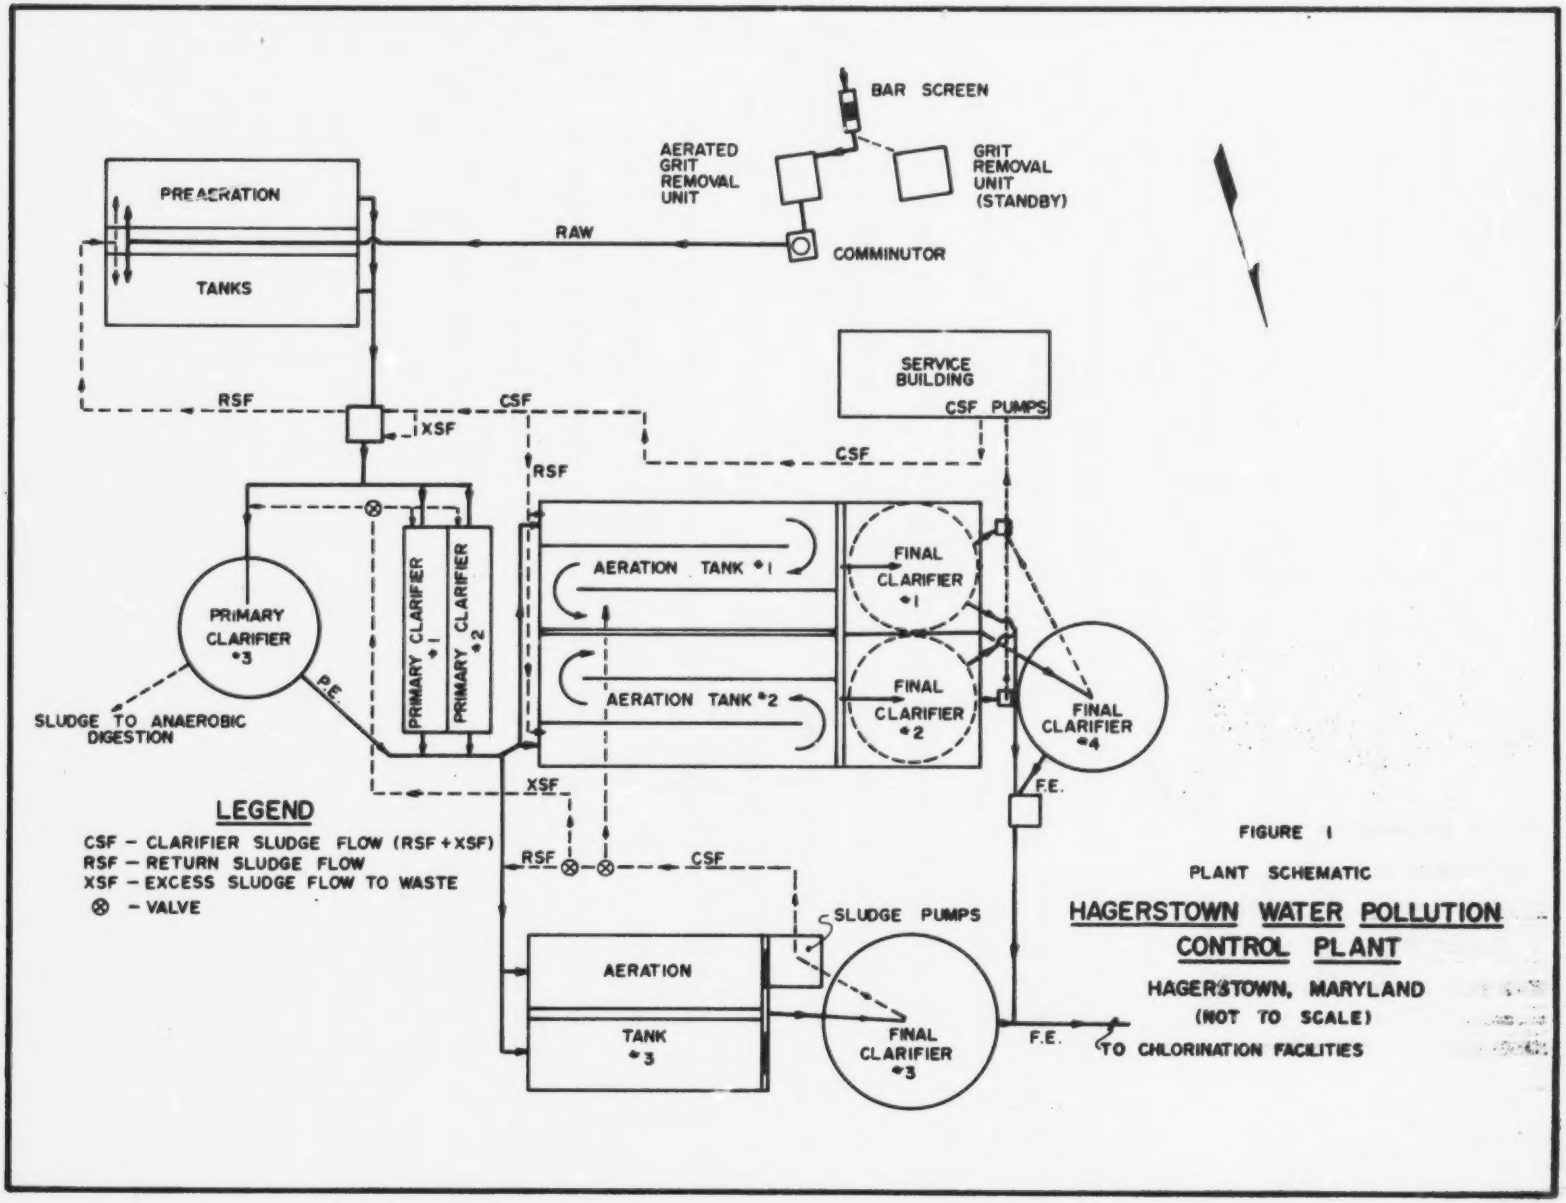
FIGURE 1

A partial flow diagram, Figure 1, illustrates the various units and the general flow pattern. In the primary system the raw waste is pre-aerated and then settled. The secondary system consists of two individual activated sludge systems each of which has separate final clarifiers and return sludge lines. The aeration tanks are equipped with swing-type air diffusers arranged in a spiral roll configuration. Some flexibility had been provided to enable several modifications of the flow pattern through the compartments of each tank.

Settled sludge from the final clarifiers is returned to the head of the aeration tanks, and a portion of the return sludge may also be diverted to the pre-aeration tanks to achieve some degree of pretreatment of the incoming waste. Excess sludge is drawn from each return sludge line to waste to the primary clarifiers. The effluent from the final clarifiers is chlorinated and discharged into Antietam Creek.
